Contemporary changes in open water surface area of Lake Inle, Myanmar

Article in *Sustainability Science* · April 2007

Roy C. Sidle · Alan D. Ziegler · John B. Vogler

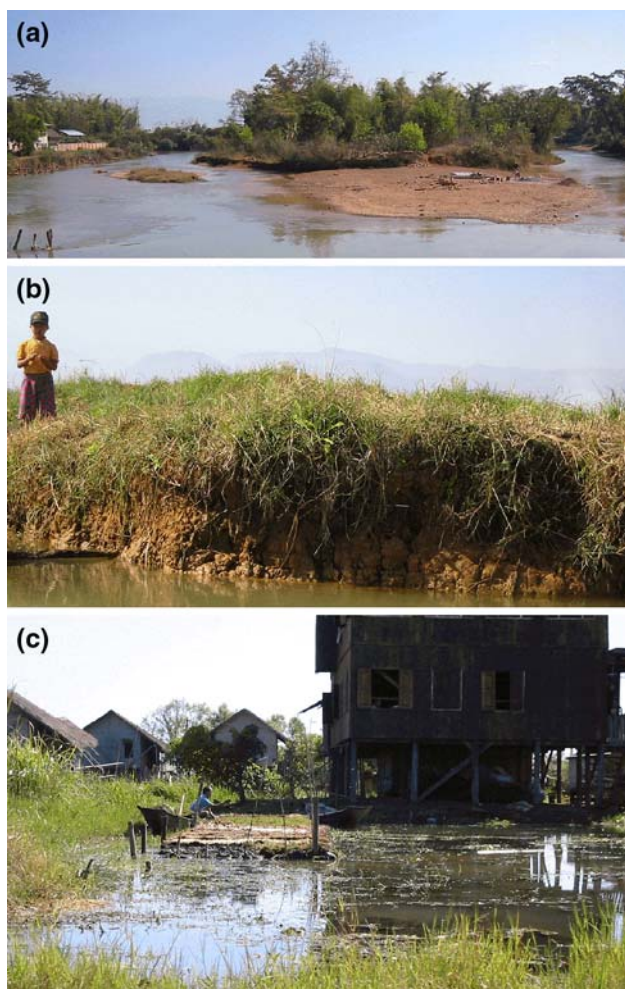
Fig. 5 **a** Sediment and channel conditions in a major tributary discharging into the birdfoot delta along the west side of Inle Lake; note the growth of vegetation on the largest sediment bar indicating that sedimentation has not been extreme in recent years; **b** bank erosion along a channel cut through the wetlands by the lake; and **c** active erosion from a newly prepared floating garden by a village on the lake

Floating gardens were introduced in the early 1960s after the military government took power (Figs. 4c, 5c). Before that time, most agriculture was practiced in the wetlands around the lake and on the lower hillslopes. Floating gardens consist of large blocks of organic-rich soils of low bulk density (i.e., less than water) that are excavated from wetlands around the lake (Fig. 5c). Dense thickets of *kaing* grass grow in these swampy areas, allowing organic materials to accumulate. Blocks of these organic soils about 2 × 40 m are cut and transported into places along the lake margin where they are staked by bamboo poles (Su and Jassby 2000). The organic blocks are typically ≤1 m deep, with the upper surface extending 10–20 cm above the water. Major crops grown in floating gardens include tomatoes, potatoes, beans, garlic, and flowers. The floating gardens are now popular tourist attractions. To maintain the productivity of the gardens, pesticides, fertilizer and fungicides are applied; given the hydroponic nature of the cultivation these chemicals easily find their way into the lake (Myo Myint 2000). A common practice is to ‘transport’ the floating gardens to the perimeter of the lake once their fertility is exhausted; normally this is about a 3-year period (Fig. 4d). Thus, this practice contributes to the apparent disappearance of the lake surface.

Field inspection of the downstream reaches of several streams entering the lake showed no evidence of recent excessive sediment storage that would characterize systems that were receiving huge inputs of anthropogenically generated sediment—e.g., no large, active gravel/sediment bars or widespread braiding features were present (Fig. 5a; Lisle 1982; Xu 1991; Goswami et al. 1999). Based on comparison of recent satellite images with the 1935/1937 maps, the large birdfoot delta along the west margin of the lake formed due to sedimentation much earlier than 1935. The actual structure of the delta experienced little change during the period from 1935/1937 to 2000 (Fig. 2)—temporal changes (loss of open water) were attributed to occupation by abandoned or active floating gardens (Fig. 6b, c). As noted in studies of other fluvial systems (Brierley and Murn 1997; Knox 2001; Rommens et al. 2006), such downstream sediment effects may lag the original erosion sources by several years to many decades. Thus, some of the logging-related sediment may still reside in headwater channels. However, the absence of dramatic deposition in these downstream reaches suggests that the role of contemporary sediment contributions to losses in lake area have been overstated. Important sources of recent sediment appear to be streambank erosion and excavation and dredging of navigation channels through wetlands to access floating gardens and villages on the lake, but it is difficult to judge relative magnitudes of these contributions (Fig. 5b).

We propose here that significant contemporary sediment contributions to Inle lake appear to be related to intensive cultivated agriculture in scattered, flat-lying areas near the lake; localized grazing and trampling of stream banks and streams; paths and roads around the lake; residential development; increasing tourism; and, very importantly, “in-lake” disturbances related to the creation of floating gardens. This latter practice of excavating densely rooted *kaing* vegetation together with its organic-rich soil contrib-
